MEMORANDUM

TO: Brad Phelps, Project Manager, CH2M Hill
FROM: Brad Gamble, Henry Hunt and Sam Stowe,
Layne Ranney Collector Wells
RE: Results: Ostrander Rock Property Site - OB-3 Test Boring
Cowlitz River Alluvial Aquifer Collector Well Feasibility Study

DATE: July 19, 2016

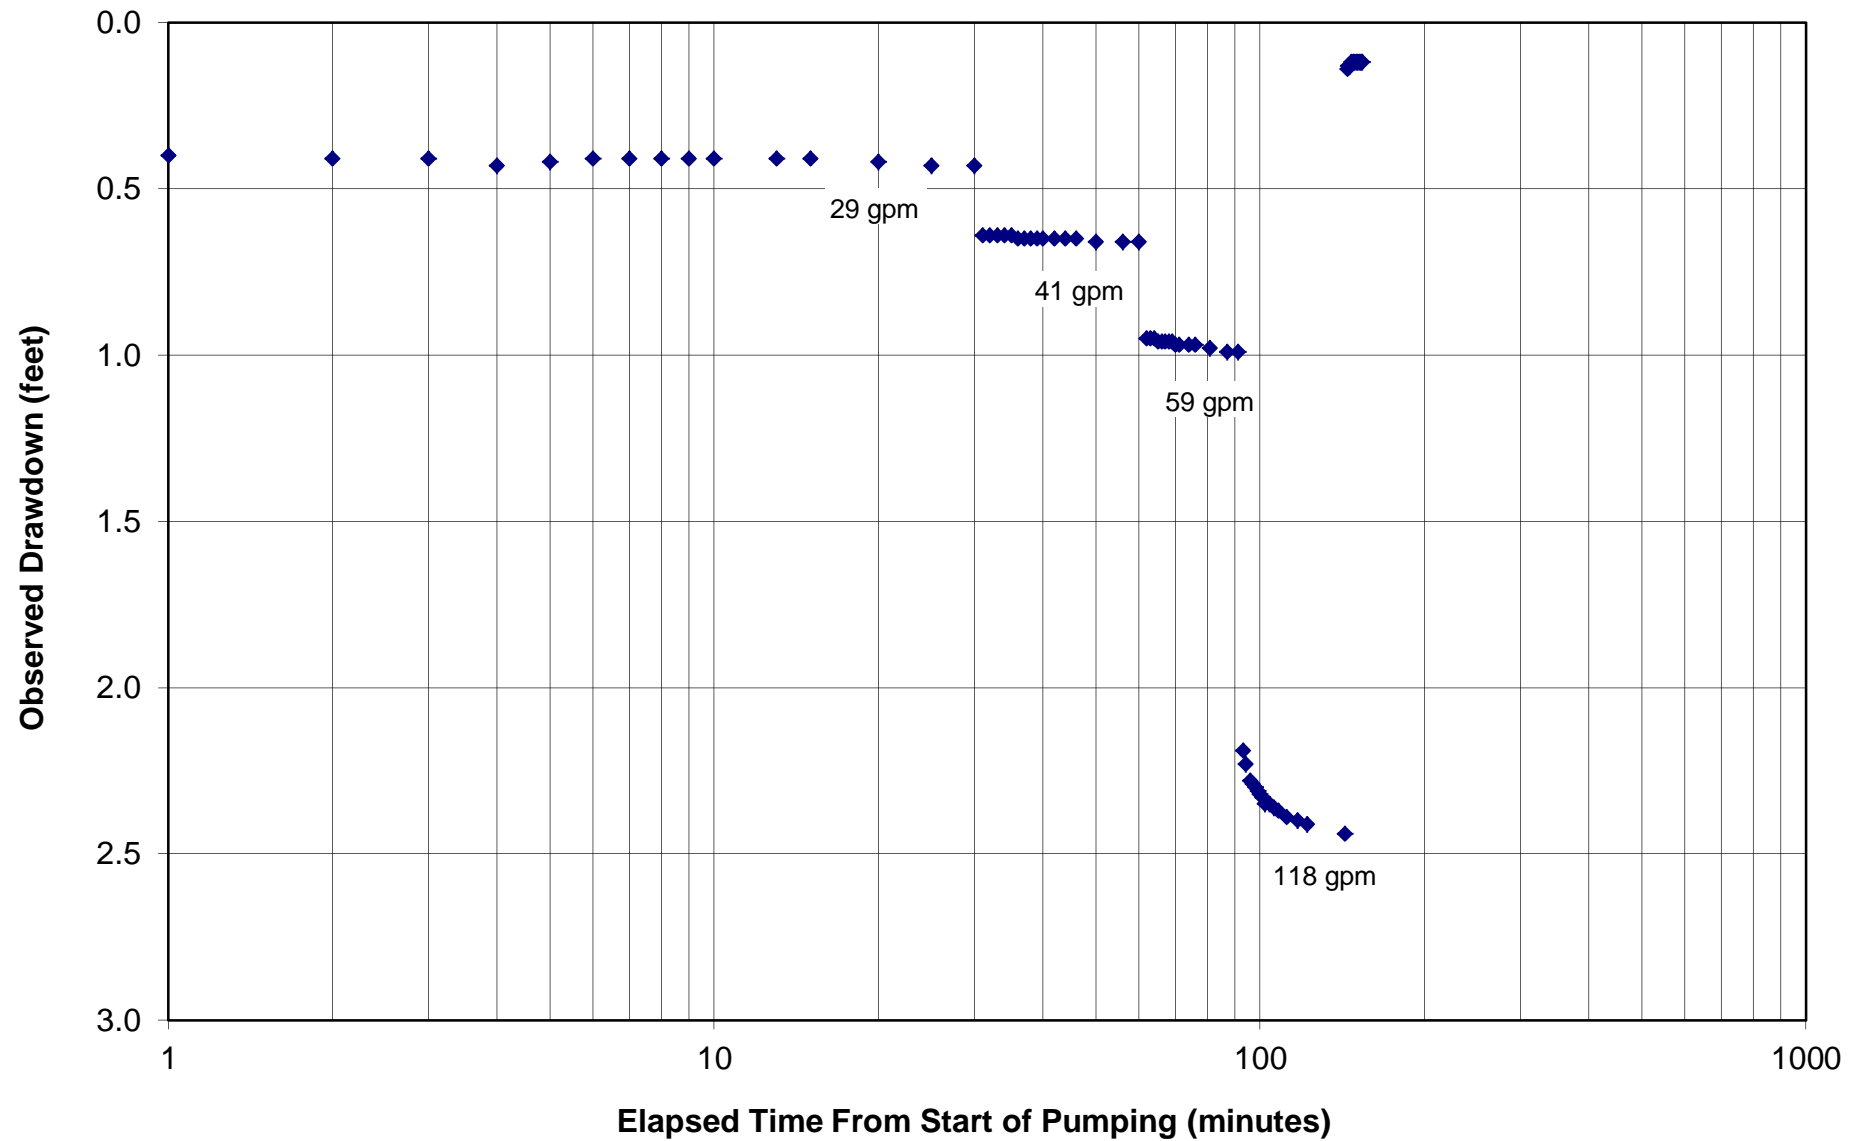
FIGURE 3
Boring OB-3 Hydraulic Interval Test Time Versus Drawdown Plot
CH2M - City of Longview, Washington

The OB-3 hydraulic interval pumping test data are presented in Attachment 3 and a summary of the pumping test results is presented in Table 3. A time drawdown plot for the pumping test is presented in Figure 3.

The observed drawdown value (the difference between the static and the pumping water levels in the well) at the end of the step at the maximum pumping rate of 118 gpm was 2.4 feet. The observed specific capacity (the ratio of the pumping rate to the drawdown) for this step is 48 gallons per minute per foot of drawdown (gpm/ft).

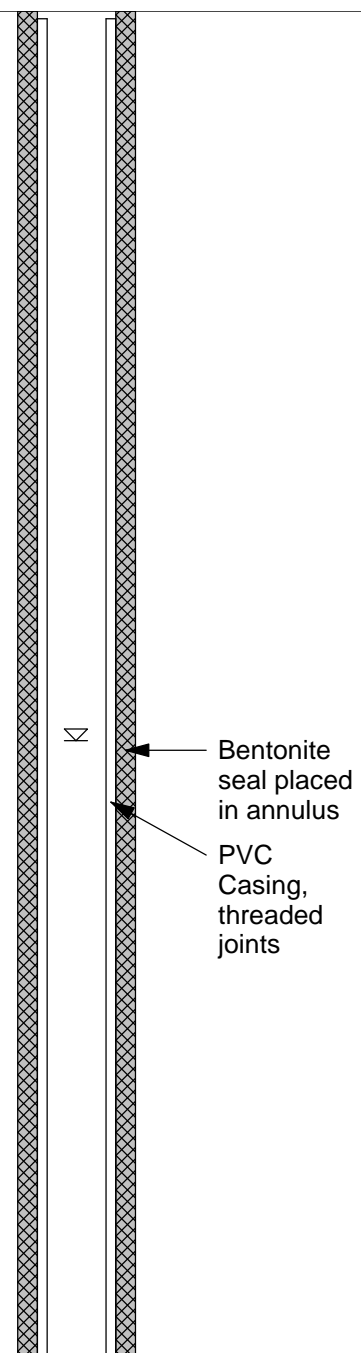
DEPTH (feet)	ELEVATION (feet)	LITHOLOGY	RECOVERY	WELL CONSTRUCTION
0		Silty Sand, brown, mostly very fine to coarse sand, trace to 10% silt, trace clay, loose, dry to moist.	0 to 6 feet, 4 feet recovery

5	30	Sand, brownish gray, very fine to very coarse sand, mostly medium, occasional granules, pebbles and cobbles, loose, dry.		
10	25	Sand, gray, very fine to very coarse, mostly coarse, trace granules and pebbles, loose, dry, clayey zone with wood fragments at about 10 feet.	6 to 16 feet, 10 feet recovery	
15	20	Clayey Silt, brown mottled gray, mostly silt, trace clay, trace fine sand, slightly cohesive, moist.		
20	15	Silty Sand, brown, very fine to medium sand, mostly fine, trace to 10% silt, slightly cohesive, moist.		
25	10	Sand, brown, very fine to coarse, mostly medium, loose, dry to moist	16 to 26 feet, 9 feet recovery	
30	5	Silty Sand, brown to reddish brown, some gray layering, very fine to medium sand, mostly fine, trace to 10% silt, slightly cohesive, moist to wet.

35	0	Sand and Gravel, gray grading to reddish brown at about 21 feet, 50-70% very fine to very coarse sand, mostly coarse, 30-50% granules and pebbles up to 2-1/2 inches, rounded to subrounded, loose, wet.		
		Sand and Gravel, reddish brown, 70-90% very fine to very coarse sand, mostly coarse, 10-30% granules and pebbles up to 2 inches, rounded to subrounded, loose, wet.	26 to 36 feet, 10 feet recovery	
		Sand and Gravel, dark gray, 50-70% very fine to very coarse sand, 30-50% granules and pebbles up to 1 inch, rounded to subrounded, loose, wet, numerous light gray pumice granules

DEPTH (feet)	ELEVATION (feet)	LITHOLOGY	RECOVERY	WELL CONSTRUCTION
35		and small pebbles.		
		Sand and Gravel, dark gray, 60-80% very fine to very coarse sand, mostly coarse, 20-40% granules and pebbles up to 1 inch, rounded to subrounded, loose, wet, several pieces of charred wood and pumice pebbles at 36 feet.	36 to 46 feet, 9 feet recovery	
40	-5			
		Sand and Gravel, dark gray, 40-60% very fine to very coarse sand, mostly coarse, 40-60% granules, pebbles and numerous cobbles up to 4 inches, rounded to subrounded, trace silt, loose, wet.		
45	-10			
			46 to 56 feet, 8 feet recovery	
50	-15			
				PVC screen, 0.010-inch slot set at 41-51 feet
55	-20	Partially decayed wood, dark brown, friable, wet.		
		Sand, dark gray, very fine to very coarse, mostly coarse, trace granules and occasional pebbles, trace silt, loose, wet.	56 to 66 feet, 10 feet recovery	
60	-25			
		Sand to Silty Sand, dark gray, very fine to very coarse sand, mostly medium, trace to 10% silt, loose, wet, layers with more silt at the bottom.

65	-30			
				Sand pack set at 38-66 feet
				PVC Casing, threaded joints

OB-3 was drilled to a total depth of 66 feet. The boring was advanced until six (6) feet of low permeability materials were encountered.

Unconsolidated alluvial deposits of relatively coarse-grained sand and gravel were present from a depth of 19 feet to 60 feet. From 60 feet to the completion depth of the boring at 66 feet, the materials encountered were comprised mainly of sand to silty sand. These materials would have lower permeability than the overlying sand and gravel, and would tend to impede recharge to any more permeable deposits that might be present at greater depths. The grain size distribution of the coarse-grained alluvial deposits encountered in the borings varied from nearly all sand to more than 70% gravel (based on the Wentworth grain size classification).
