LONGVIEW PEDESTRIAN CROSSING ASSESSMENTS 3RD AVE & 30TH AVE

THURSDAY, APRIL 12, 2018

3rd Avenue Crossing Assessment

30th Avenue Crossing Assessment

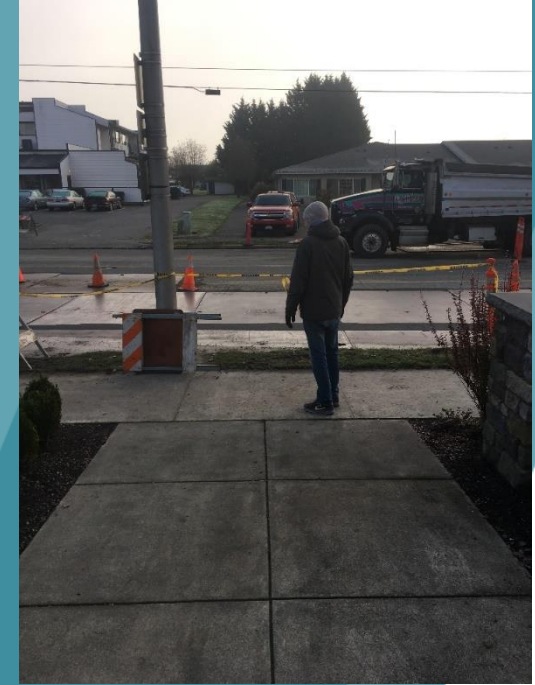
3rd Avenue Crossing Assessment

- Traffic Data
 - Traffic volumes: 15,320 daily
 - 989 morning, 177 afternoon, 1,308 evening
 - Travel speeds: 32 mph daily
 - Pedestrian activity: 42 between 7am-7pm
 - 5 morning, 14 afternoon, 5 evening
- Other Considerations
 - Illumination
 - Topography
 - Vegetation
 - Sight distance

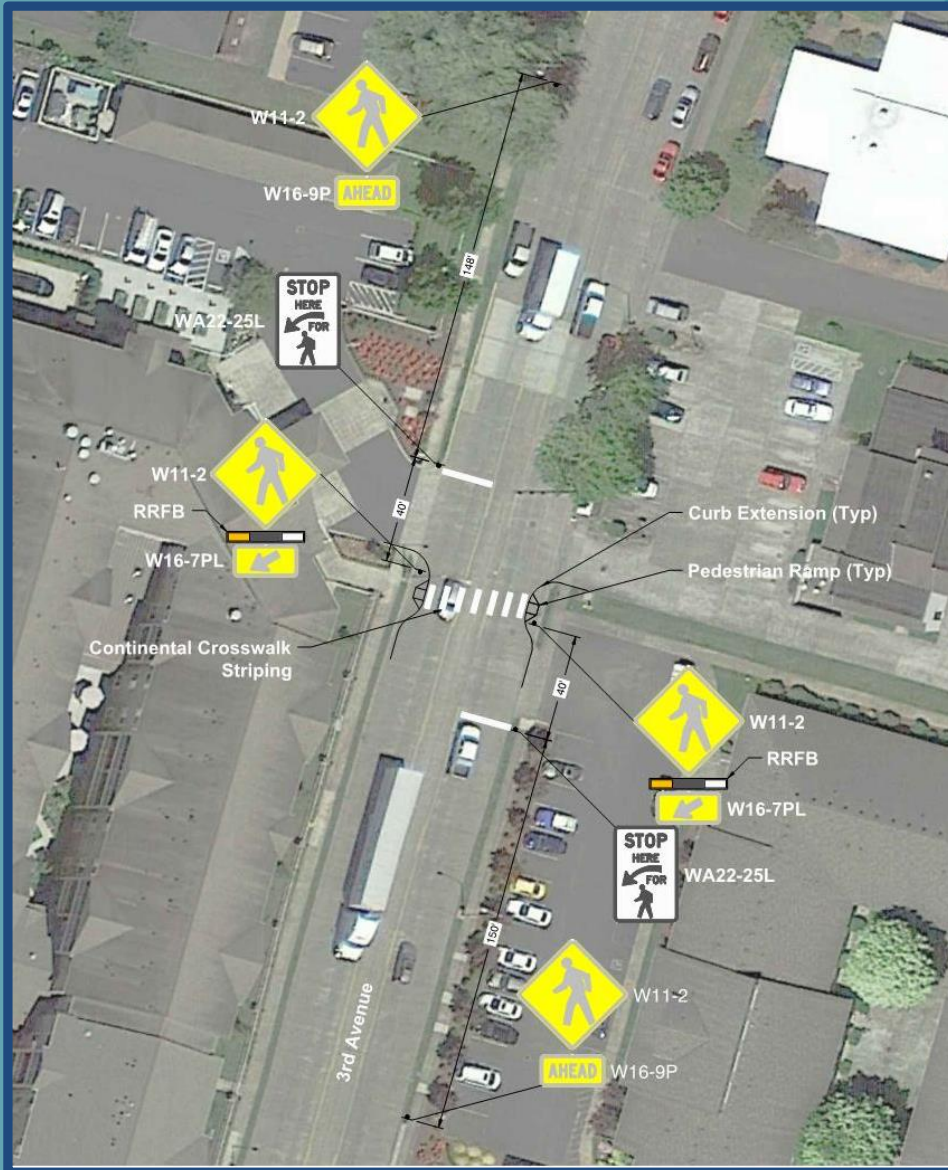
- Potential Mid-Block Crossing

- Findings and Recommendations (cont.)
 - Monitor the mid-block crossing and if/when pedestrian activity reaches the minimum requirement, consideration should be given to installing an enhanced mid-block crossing with the following crossing treatments:
 - Curb extensions on both sides of the proposed mid-block crossing.
 - ADA compliant pedestrian ramps at both ends of the crosswalk per City standards.
 - High visibility crosswalk pavement markings and signs per the MUTCD.
 - Rectangular Rapid Flash Beacons (RRFB) on the crosswalk signs.
 - Advance stop bars at each approach with “Stop Here for Pedestrian” signs.
 - Advance warning signs at each approach.

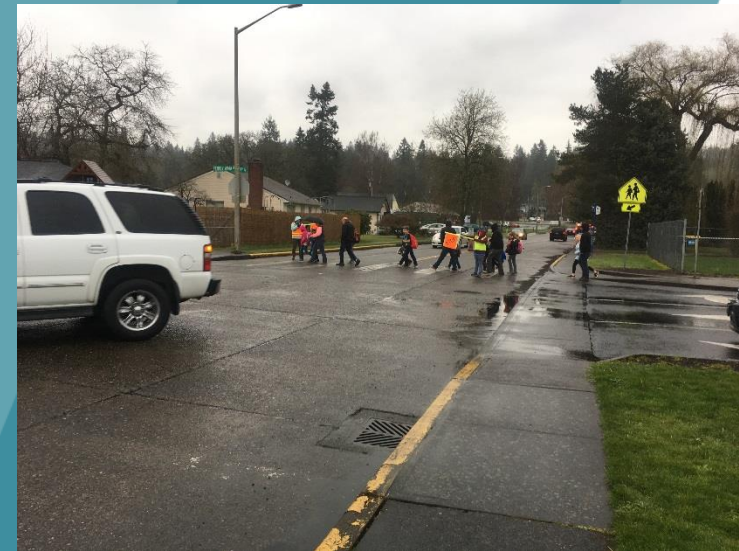
30th Avenue Crossing Assessment

- Traffic Data
 - Traffic volumes: 5,586 daily vehicles: 387 morning; 560 afternoon
 - Travel speeds: 30 mph daily: 21 mph morning; 22 mph afternoon
 - Pedestrian activity:
 - Pennsylvania Street: 25 morning; 119 afternoon
 - Pine Street: 4 morning; 37 afternoon
 - Mid-block: 0 morning; 1 afternoon
- Other Considerations
 - Illumination
 - Topography
 - Vegetation
 - Sight distance
