**Jurisdictional  
Wetland Delineation Report  
and  
Buffer Reduction and Enhancement  
Plan  
for the  
Bakers Corner Fire Station #22  
Longview, Washington**

Ecological Land Services, Inc.  
1157 3<sup>rd</sup> Avenue, Suite 220A  
Longview, Washington 98632  
(360) 578-1371  
ELS Project #2521.01

April, 2017

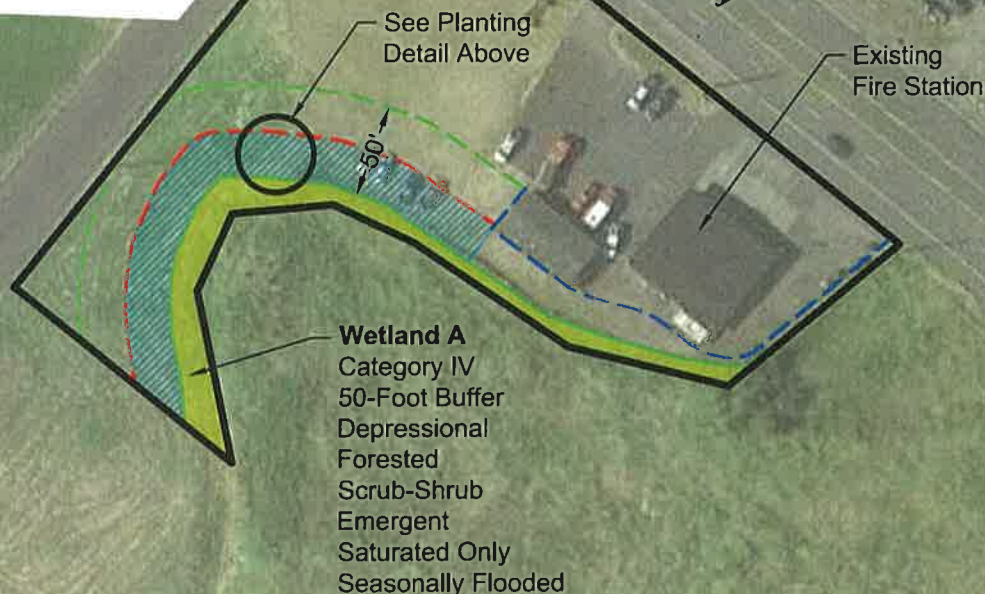
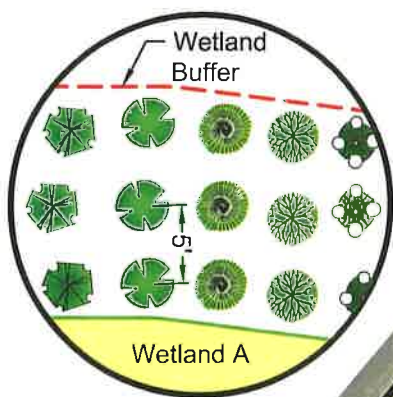
**Figure 3**  
**PROPOSED CONDITIONS AND PLANTING PLAN**  
 Bakers Corner Fire Station  
 Rice Fergus Miller  
 City of Longview, Cowlitz County, Washington  
 Section 14, Township 8N, Range 3W, W.M.

Planting Detail

1. Aerial photograph from Google Earth™.
2. Plants are not to scale and location are approximate as shown. Actual planting locations will be determined in the field, with consideration to the listed spacing and density to produce the most natural appearance possible.

According to *LMC 17.10.110(6)*, a buffer may be reduced if the applicant undertakes department-approved buffer enhancements including, but not limited to, planting of noninvasive, native trees or shrubs, diversification of plant cover types, or replacement of invasive exotic species with natives. A planting plan is required, as well as adherence to mitigation standards outlined in *LMC 17.10.160, Mitigation plan performance standards*. This buffer cannot be reduced by greater than 50 percent of the required buffer and cannot be less than the low-intensity land use buffer threshold, as stipulated in *LMC Table 17.10.110(4)(a)* and *LMC 17.10.110(7)*. The applicant proposes to reduce the 50-foot buffer to 25 feet and enhance the remaining 7,613-square feet of the buffer by removal of the invasives, which include reed canarygrass and Himalayan blackberry, and installation of native plants. The proposed buffer enhancement will provide an ecological lift by installing native plants that will increase the buffer function through increase the vegetation quality and diversity. The enhancement plantings will provide screening to Wetland A from surrounding land uses, prevent erosion, as well as create a densely vegetated natural barrier at the edge of Wetland A (Figure 3).

The planting plan proposes to install common native lower growing shrub species within the reduced buffer to encourage the development of a dense herbaceous and shrub community as well as a varied habitat opportunity. The shrubs selected for installation within the buffer include Oregon grape (*Mahonia aquifolium*), red flowering currant (*Ribes sanguineum*), oceanspray (*Holodiscus discolor*), snowberry (*Symphoricarpos albus*), and Scouler's willow (*Salix scouleriana*). Plants will be installed in the late fall to early spring when the site conditions are wettest and the plants are dormant. Plants will be installed in mono-specific groups to better mimic the natural environment and enhance plant survival. One gallon container stock was selected over bare root stock due to better developed root systems and planting mediums, as the soil conditions (mostly fill) of the buffer are generally poor. Potted gallon stock will be more successful. The following table summarizes the plant species, spacing, and quantities for the buffer enhancement area (Table 2).
