To: Jeff Cameron, Amy Blain – City of Longview **Date:** July 17, 2016
From: Stephen Booth, Michael Hallett, and Melinda Friedman – Confluence **Project:** Softening Alternatives & Baltimore Street Water Quality Evaluation
Cc: **Subject:** In-Home DO Trials Technical Memorandum FINAL

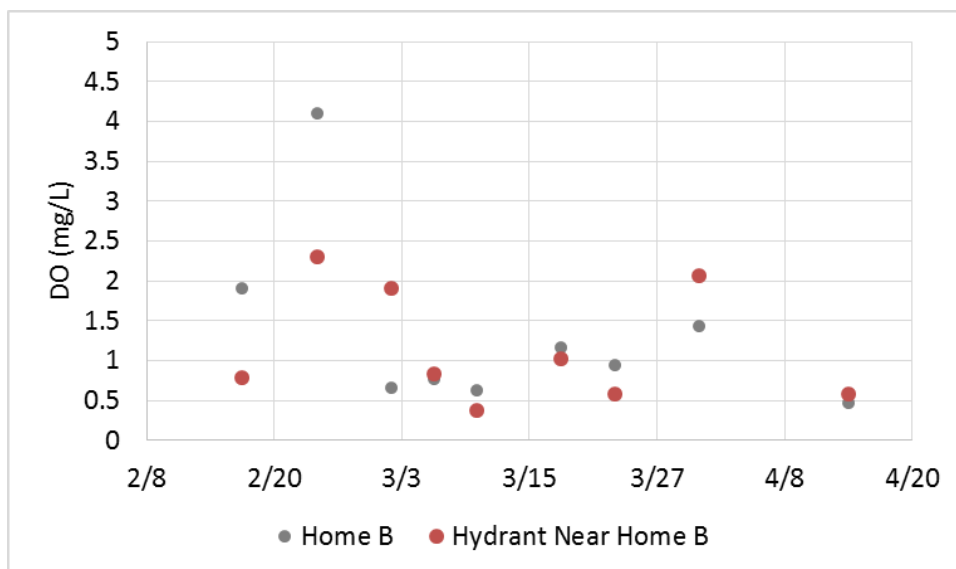
Figure 2. Routine weekly DO data for Home B.

Weekly DO data collected during routine sampling at the hose bib of each home after the installation of the aeration equipment are presented in Figures 1 and 2 for Homes A and B, respectively. Slightly elevated DO was consistently observed at Home A compared to the distribution system samples collected at a hydrant near the home. DO levels remained well below the target range of 4 to 8 mg/L throughout the duration of this pilot test. There was more scatter in the DO data for Home B and DO levels within that home remained below the DO of the distribution system water for most of the duration of the test.

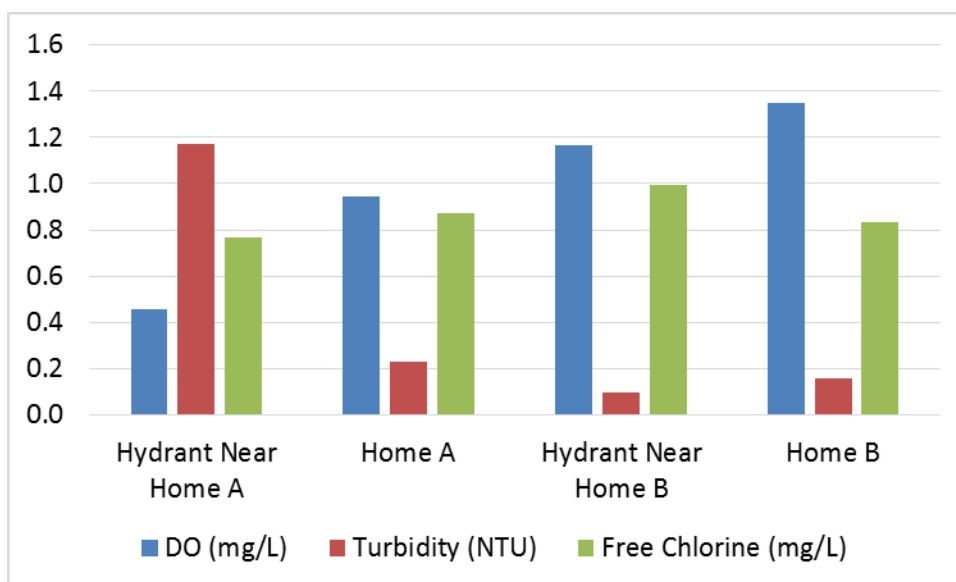
Figure 3. Average routine water quality monitoring data.

Average water quality data for each home are presented in Figure 3.

On average, DO was somewhat higher within Homes A and B compared to the distribution system, however, the increase in DO was negligible so the effect of elevated DO on in-home water quality could not be adequately assessed. Turbidity was lower in Home A compared to the distribution system, and free chlorine residuals were similar in the home compared to the hydrant for both homes. The differences between free and total chlorine residuals were found to be within 0.1 to 0.2 mg/L throughout this testing.

for both homes. For Home B, average turbidity was comparable within the home as in the distribution system. Free chlorine levels were lower in the home compared to the distribution system. ORP levels averaged approximately 580 mV for Home A and 640 mV for Home B. Both homes had similar levels of ORP compared to that of the distribution system.

The average apparent color for Home A was 4.9 CU compared to 12.6 CU at the hydrant. For Home B, apparent color was found to be similar within the home and at the nearby hydrant, with average values of 2.4 CU and 1.7 CU, for the home and the hydrant, respectively.

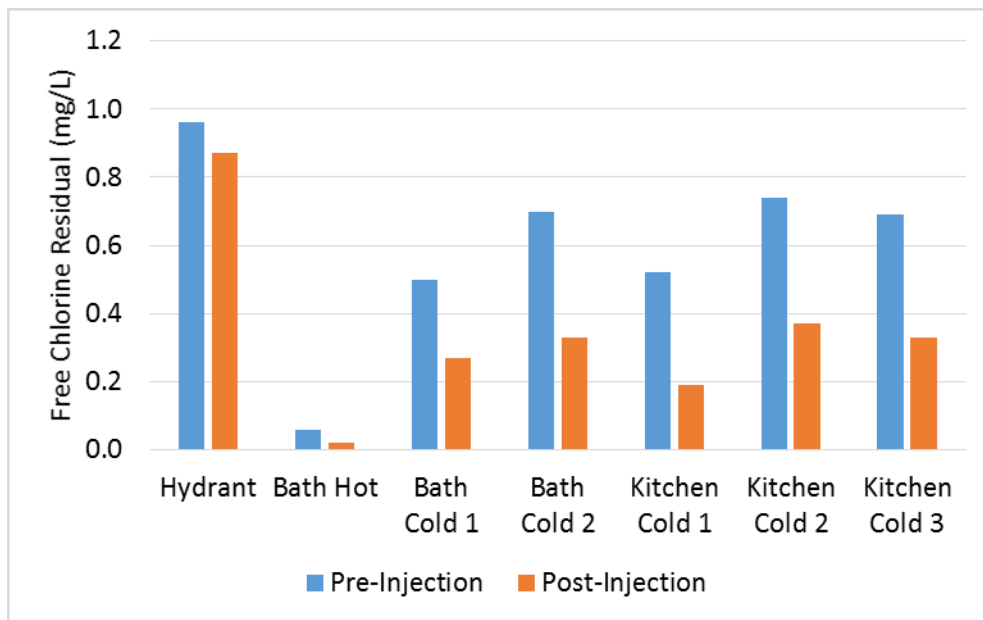
Figure 4. Free chlorine residual data for Home A.

The difference between free and total chlorine residuals was generally less than 0.1 mg/L (suggesting that combined chlorine compounds had been oxidized within the distribution system upstream of these homes). Free chlorine residuals were similar in the distribution system pre- and post-injection (Figure 4). Post-injection chlorine residuals were consistently lower within Home A compared to the hydrant, including both aliquots collected at the cold water tap in the bathroom, all three aliquots collected at the cold water tap in the kitchen, and the hot water tap in the bathroom. Loss of free chlorine residual between the sampling locations within the home and the hydrant was higher post-injection compared to pre-injection for Home A (Figure 5).

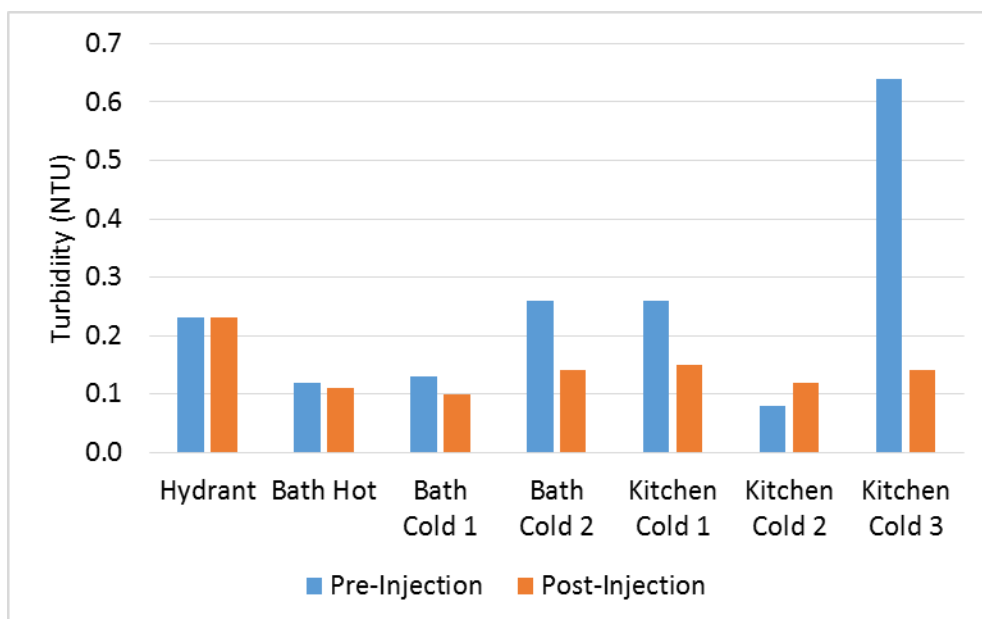
Figure 6. Turbidity data for Home A.

Pre- and post-injection turbidity levels were generally similar, with the exception of the third aliquot of water collected from the cold tap in the kitchen, which was much higher for the pre-injection sample (Figure 6).

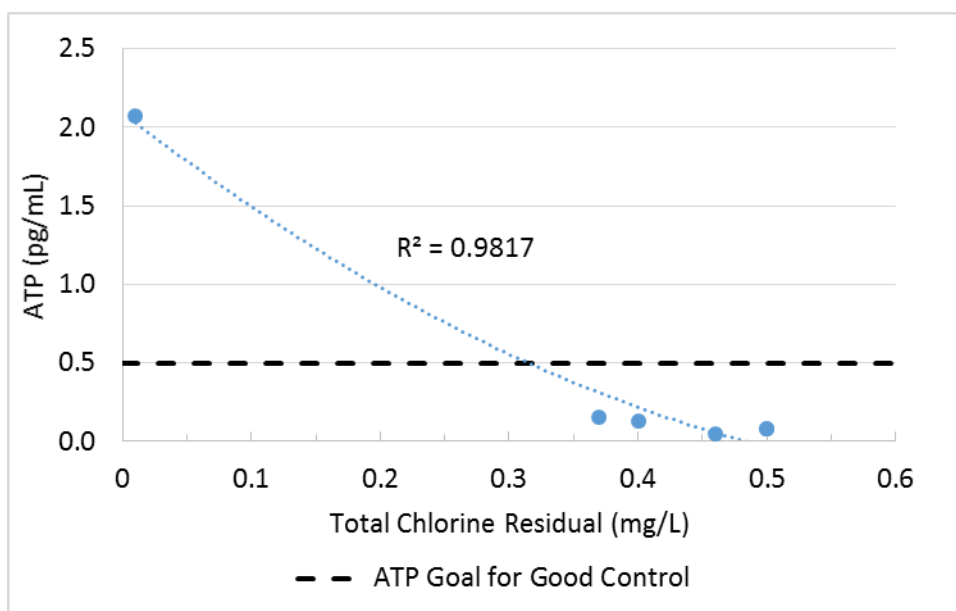
Figure 10. Total chlorine vs. ATP for Home A.

ATP levels were consistently low for Home A both pre- and post-injection, with the exception of the bathroom hot water tap, for which ATP levels were somewhat elevated at the end of the DO trial (Figure 9). ATP levels within the homes were strongly influenced by chlorine levels, as shown in Figure 10 for Home A. According to the ATP method manufacturer, ATP levels less than 0.5 pg/mL are considered low and indicate good microbial control in drinking water. Levels between 0.5 - 10 pg/mL suggest a review of preventative strategies. Levels greater than 10 pg/mL indicate the need for corrective action.

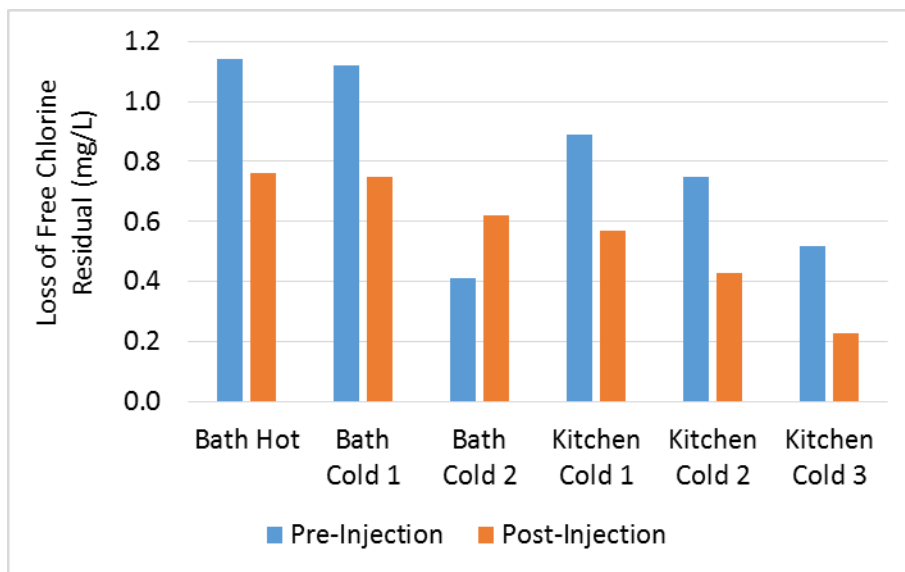
Figure 13. Chlorine residual loss data for Home B.

Post-injection free chlorine residuals were correspondingly lower at all sample locations within Home B compared to pre-injection. Post-injection loss of free chlorine residual between the sampling locations within the home and the hydrant were lower compared to pre-injection for Home B (Figure 13).
