# CITY OF LONGVIEW

**COWLITZ RIVER COLLECTOR WELL  
ADDITIONAL EXPLORATORY WELL INVESTIGATION RESULTS  
&  
INTERIM MEASURES UPDATE**

CITY COUNCIL/BHWSD COMMISSIONER JOINT SPECIAL MEETING

JULY 28, 2016

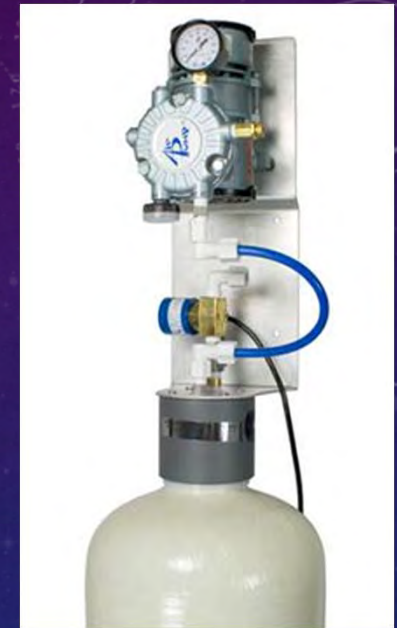
## PREMISE AERATION DISSOLVED OXYGEN TRIAL

- Evaluate effect of DO on water quality in home plumbing
- Used commercially available equipment to aerate water
- 3-mo trial in two homes (City and BHWSD service areas)
- Target DO range of 4 to 8 mg/L
- Collected pre- and post- samples from kitchen, bath (hot/cold) and hydrant
- Collected weekly samples collected from exterior hose bib and hydrant
- Conducted Flavor Rating Assessment (FRA) to identify tastes and odors
