# CITY OF LONGVIEW

**COWLITZ RIVER COLLECTOR WELL  
ADDITIONAL EXPLORATORY WELL INVESTIGATION RESULTS  
&  
INTERIM MEASURES UPDATE**

CITY COUNCIL/BHWSD COMMISSIONER JOINT SPECIAL MEETING

JULY 28, 2016

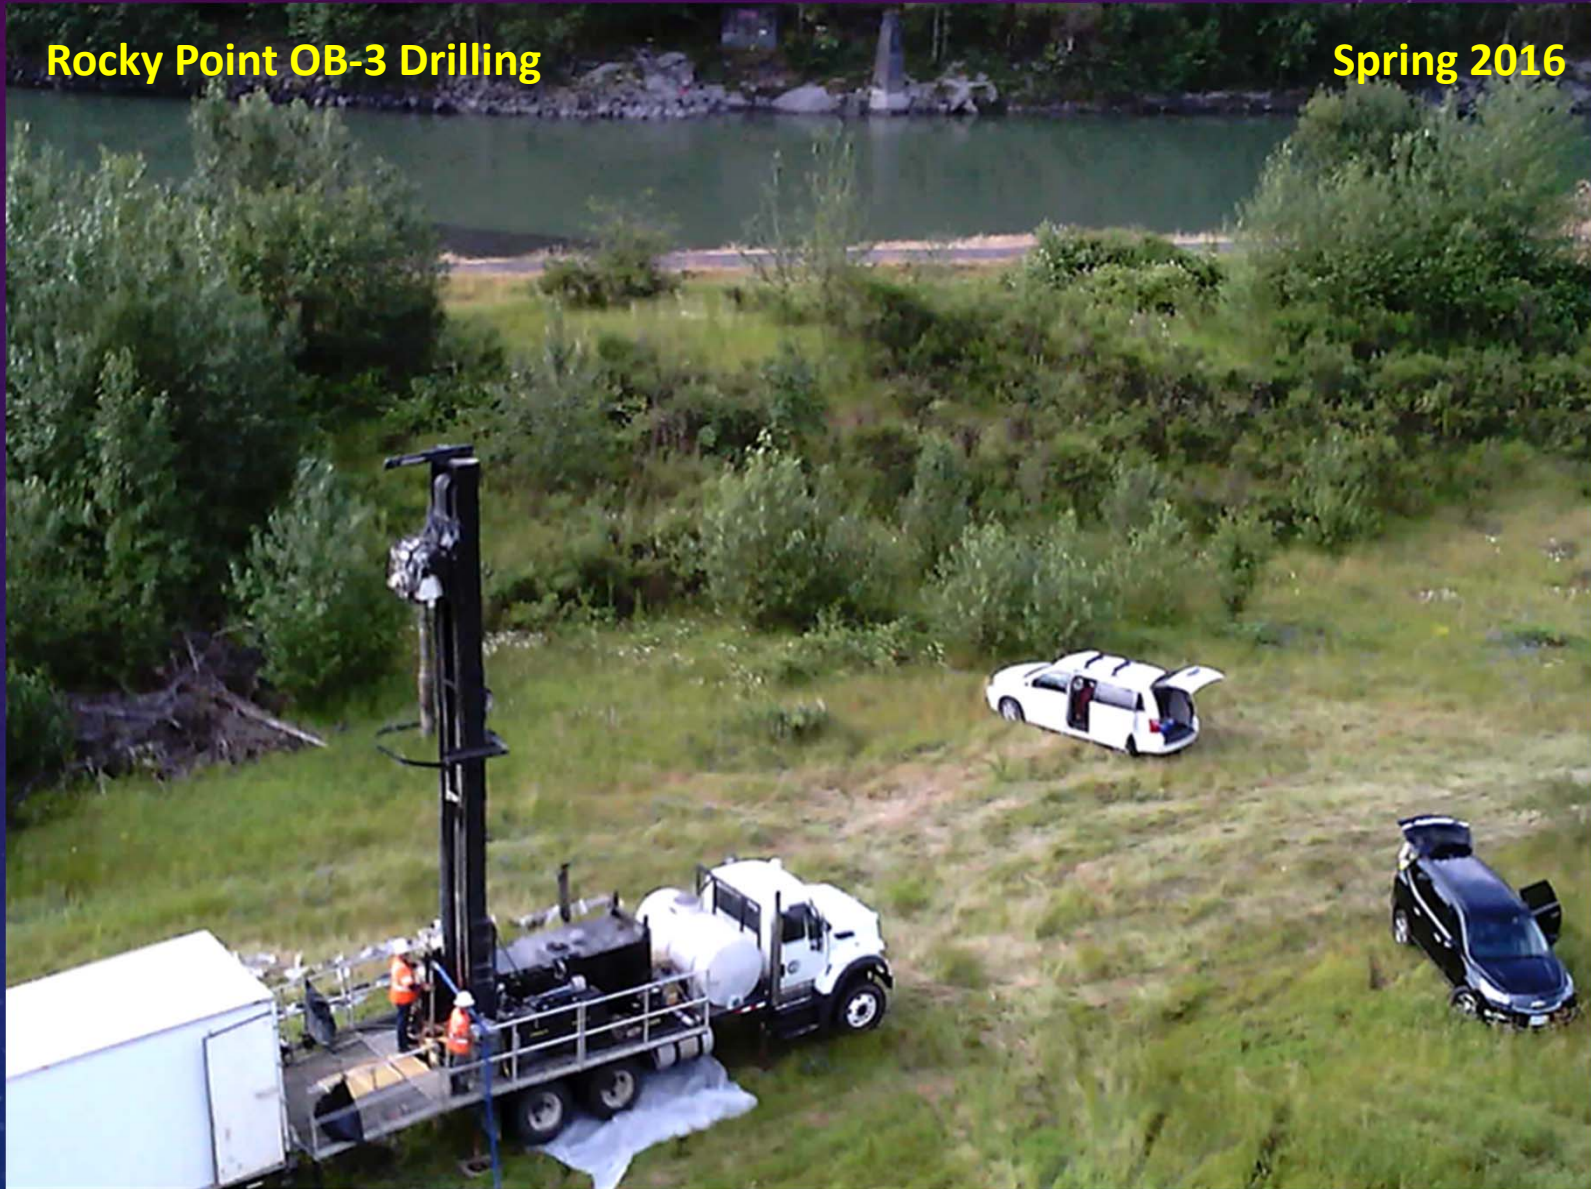
**Rocky Point OB-3 Drilling**

**Spring 2016**

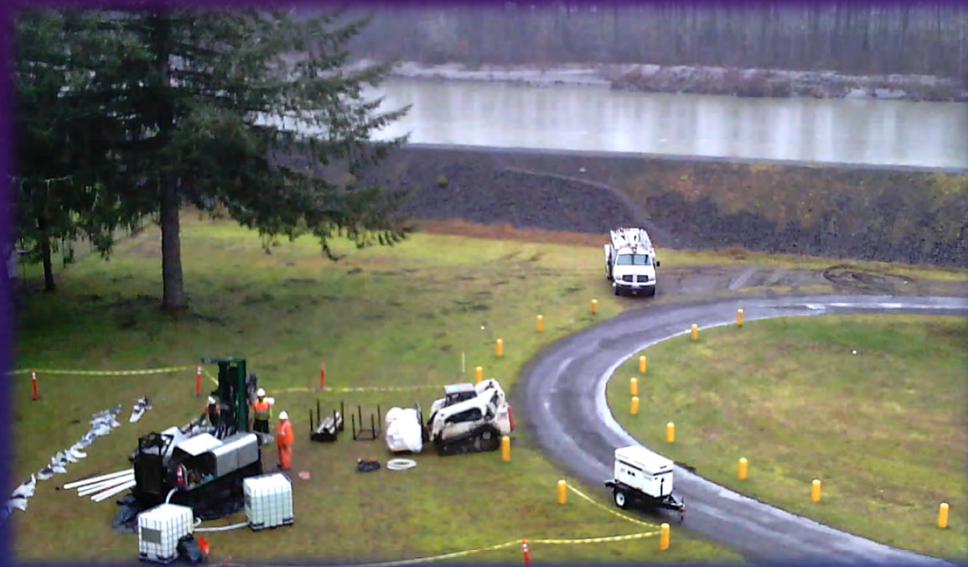
## TH-1: RIVERSIDE PARK

0'

13'

27'

50'

60'

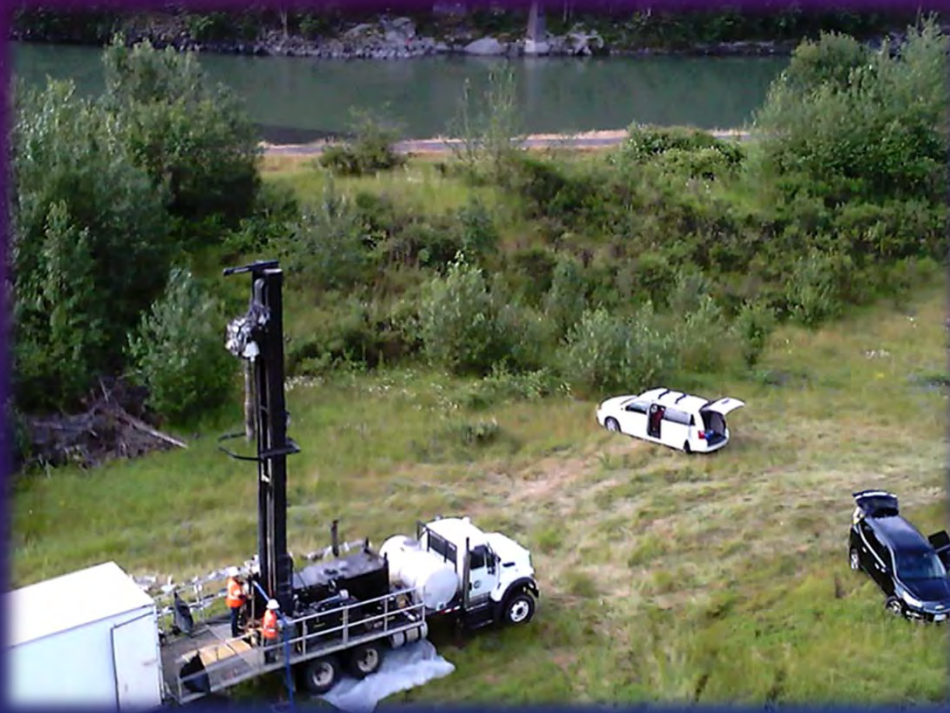
## OB-3: ROCKY POINT

Legend:	
	Sand & Gravel
	Sand
	Silty Sand
	Clay Silt
	Organic Mat'l
